**UNITED STATES ENVIRONMENTAL PROTECTION AGENCY  
REGION 5  
77 WEST JACKSON BOULEVARD  
CHICAGO, ILLINOIS 60604**

**SUBJECT:** CLEAN AIR ACT INSPECTION REPORT  
McWane Ductile, Coshocton, Ohio

**Date of Inspection:** December 9, 2015

**Purpose of Inspection:** Follow-Up Clean Air Act Inspection Regarding Fugitive Visible Emissions

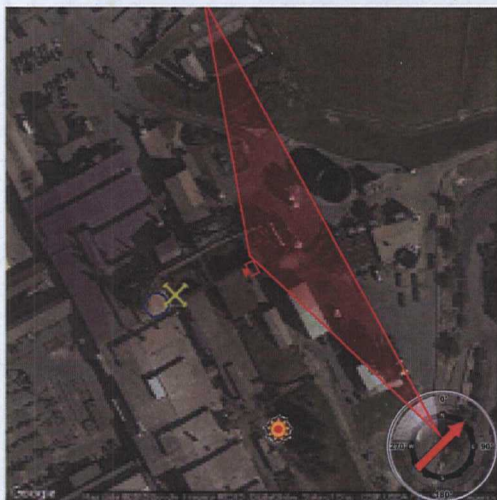
Describe Emission Point Fugitive VEs exiting under roof of Shroud			
Height of Emiss. Pt. Start 24.87 End Same		Height of Emiss. Pt. Rel. to Observer Start 20.87 End Same	
Distance to Emiss. Pt. Start 215.18 End Same		Direction to Emiss. Pt. (Degrees) Start 241.83 End Same

Describe Emissions VEs due to charging of Start furnace in shroud End Same			
Emission Color Start Dust End Same		Water Droplet Plume Attached: ( ) Detached: ( ) N/A: ( X )

Notes Photos are of fugitive visible emissions exiting under the shroud	
--	--
